SPECIAL REPORT

# Moisture in the Roofs of Cold Storage Buildings

Wayne Tobiasson and Alan Greatorex

November 1998

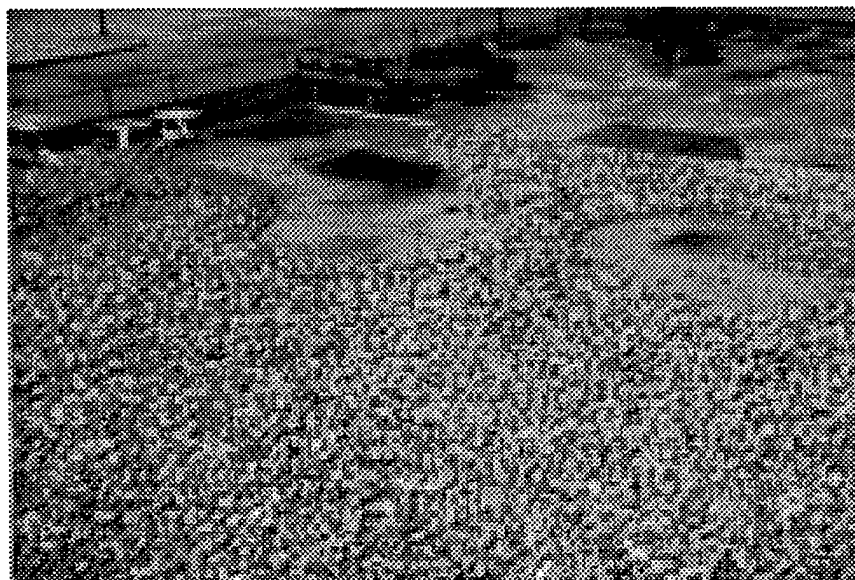
The daytime visual inspection revealed that ballast scour by wind existed in the northwest corner (Fig. 4); a portion of the north edge metal was depressed below the level of the membrane (Fig. 5); and a failed patch (Fig. 6) existed along the north edge 115 ft (35 m) from the northwest corner.

Figure 4. Ballast scour in the northeast corner of roof D1.

Most of the waterproofing membrane on this roof is in good condition. It may be wise to revise the north edge of this roof to eliminate the problem shown in Figure 5. It may also be appropriate to replace the stone ballast with roof pavers in the

northeast and northwest corners, and perhaps all along the north edge, to prevent ballast scour there. Pavers are more stable in high winds.

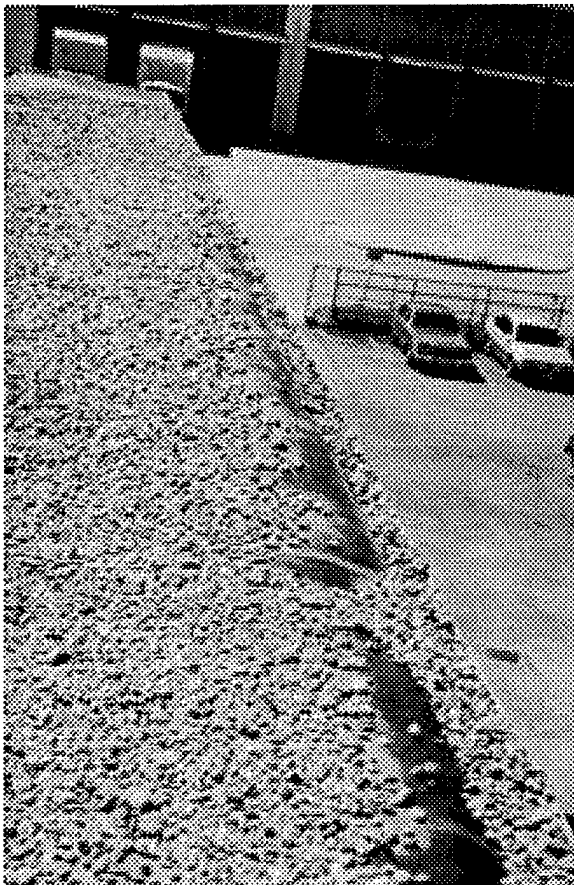
*Figure 5. Depressed edge along a portion of the north side of roof D1, looking west.*

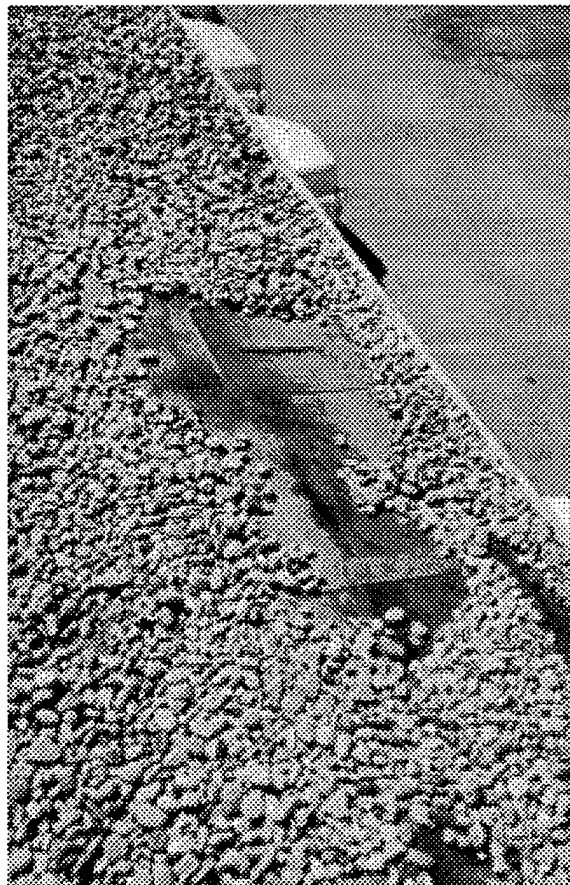
*Figure 6. Failed patch along the north edge of roof D1, looking NW.*

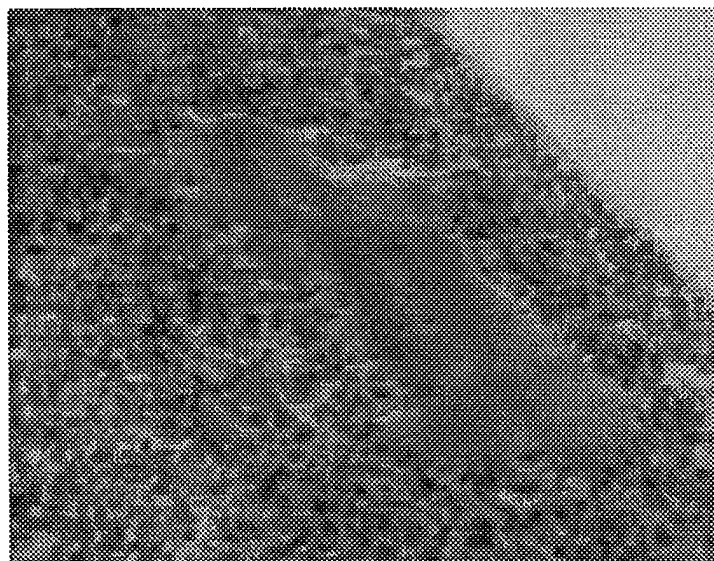
The nighttime on-the-roof infrared survey uncovered only a small area of brightness (Fig. 7) at the failed patch shown in Figure 6. Finger probing into the flaw revealed that wet insulation ex-

*Figure 7. Thermal image (thermogram) of the failed patch shown in Figure 6, looking NW.*

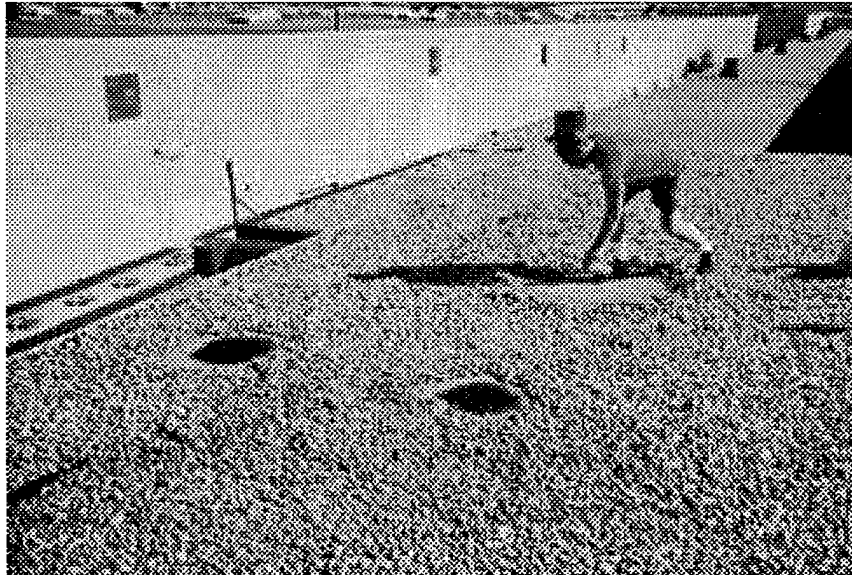
*Figure 8. Southeast corner of roof D1 showing areas cleaned for cores 1 and 2 and a larger area being prepared for core 8 and cut A, looking SE.*

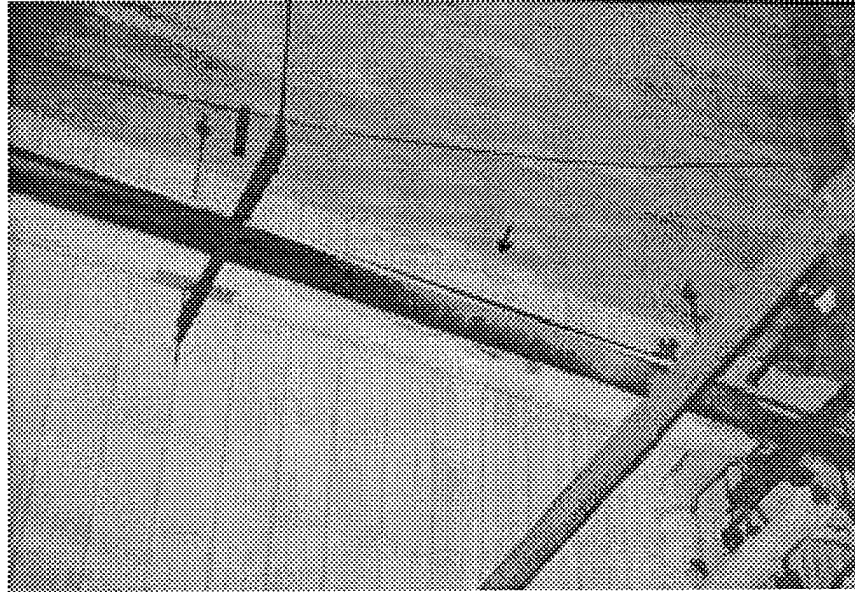
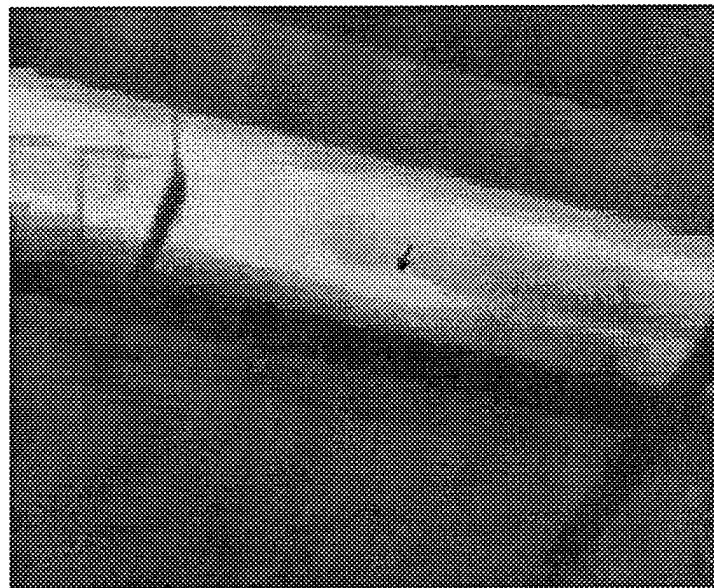
*Figure 10. Photograph and thermogram from within the D1 freezer, showing ice and air infiltration where the roof and wall join.*

a photograph and a thermogram of the area along the north side of the building where the roof and wall join. Ice is visible in the photograph and the bright thermal image indicates that warm outdoor air is leaking into the freezer along this seam. Figure 11 shows similar images taken of the northeast corner. Frost has accumulated there as warm outdoor air infiltrates into the freezer. Figures 10 and 11 indicate that air infiltration is occurring along the roof-wall intersection. The next time this freezer is warmed up, it may be appropriate to take steps to seal this joint. Spraying it with polyure-

thane foam may be worth considering. Warming this freezer could also be used to melt the ice in the fibrous glass insulation. The meltwater would probably leak out of the roof between the concrete double-tees, thereby drying out the wet fibrous glass insulation and recovering much of its lost insulating ability.

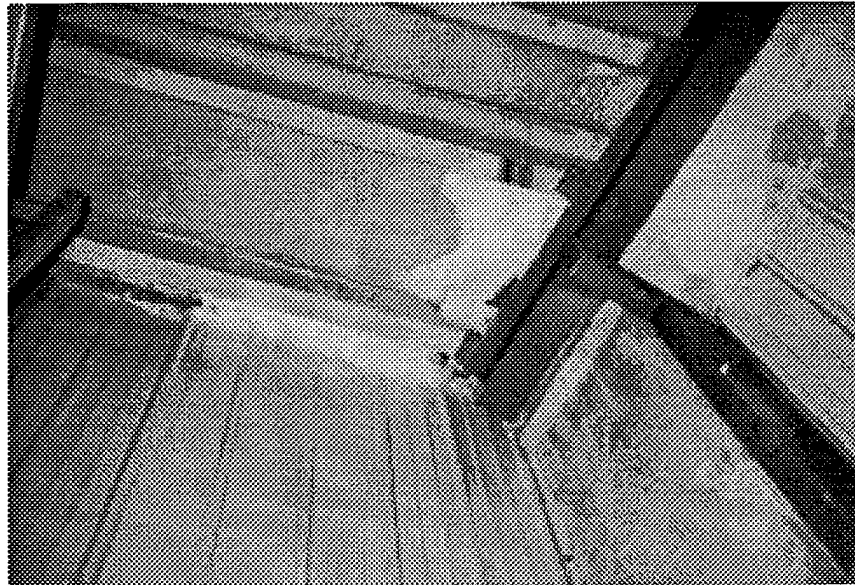
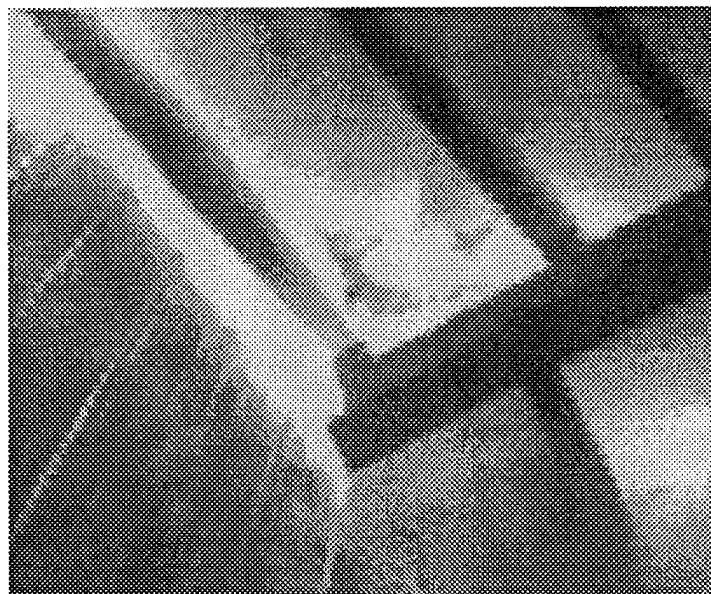
*Figure 11. Photograph and thermogram from within the D1 freezer showing frost, ice, and air infiltration in the northeast corner of the D1 freezer where the two walls and roof join.*

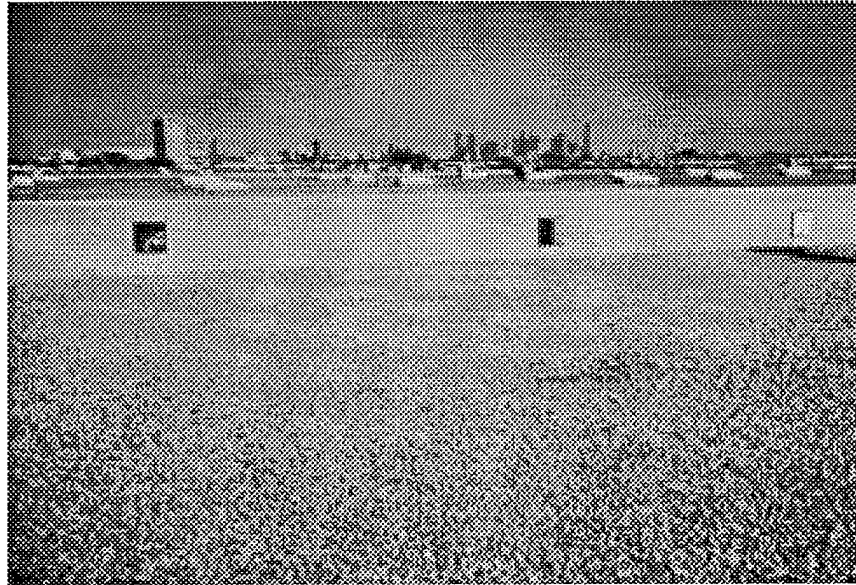
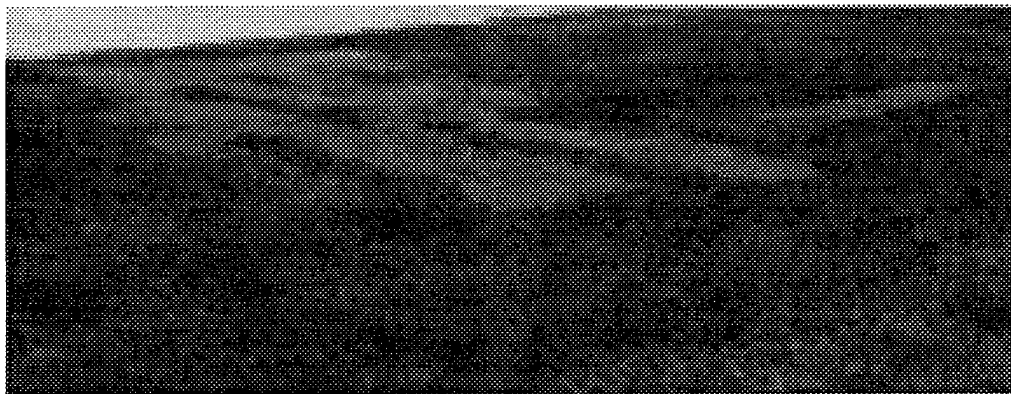
The daytime visual inspection revealed no roofing defects. During the nighttime on-the-roof infrared survey, large bright thermal anomalies were detected in the southeast corner. A few marks were made with orange spray paint there to define the general extent of these bright areas. Figure 12 shows a photograph and a thermogram of this corner of the roof. Figure 13 shows a photograph and a thermogram of a small rhombic anomaly also in this general area. That wet area is also visible at

*Figure 12. Photograph and thermogram of the southeast corner of roof D2, looking SE. The bright area on the thermogram defines where wet EPS insulation exists below the EPDM membrane.*

Leaving the wet insulation in this roof not only reduces its insulating ability but it also accelerates its rate of deterioration. It would be expensive to remove and replace all wet EPS insulation, but this option should be considered since this insulation cannot be dried out in place. The bituminous membrane below prevents downward drying.

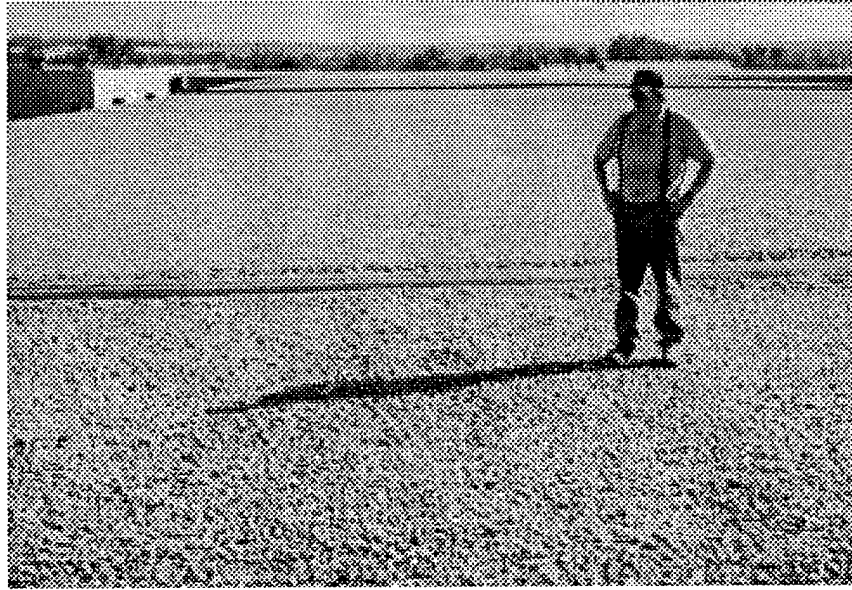
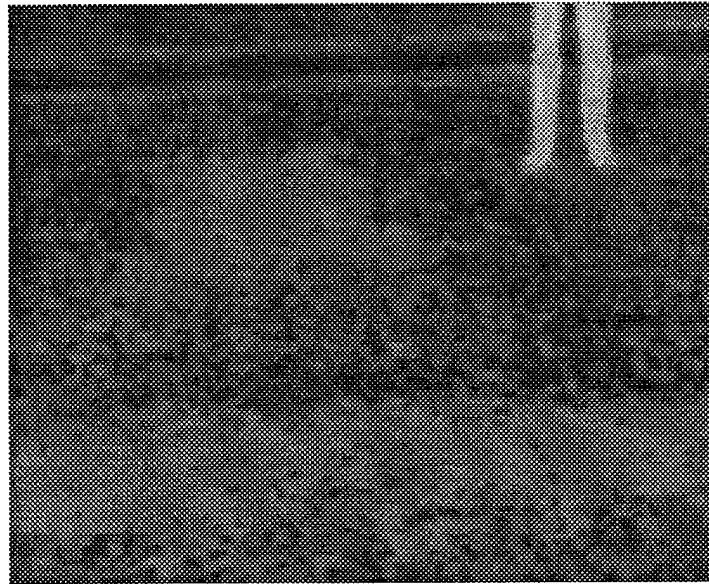
*Figure 13. Photograph and thermogram taken near the area shown in Figure 12, looking south.*

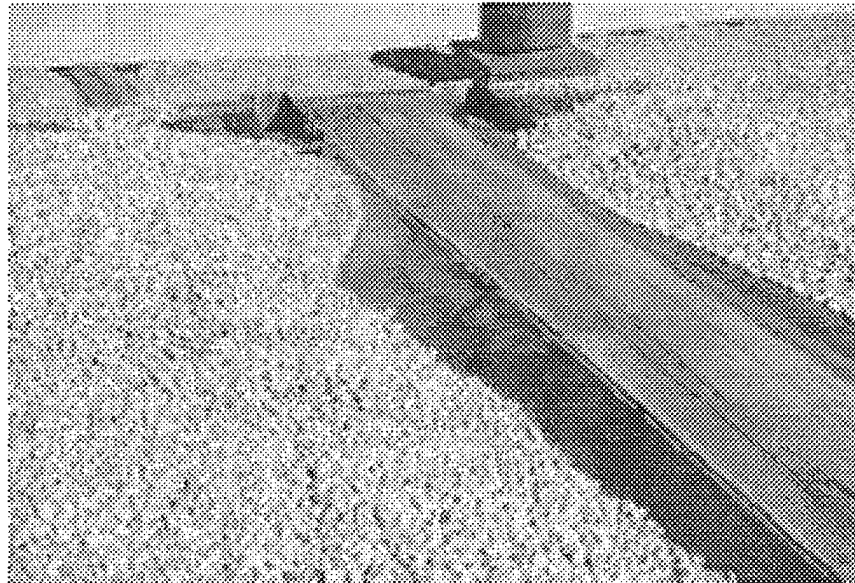
A photograph and thermogram of the east end of the expansion joint that forms the south end of roof D2 are shown in Figure 14. The insulation did not feel soft (i.e., wet) within the bright area of the thermogram. This and other evidence suggests that this warmth was caused by air infiltration from the edge of the roof. As stated for roof D1, if

*Figure 14. Photograph and thermogram of the east end of the expansion joint at the southeast corner of roof D2. The intense brightness on the thermogram is probably due to air infiltration, not wet insulation.*

and when this freezer is warmed up, such air infiltration paths should be blocked.

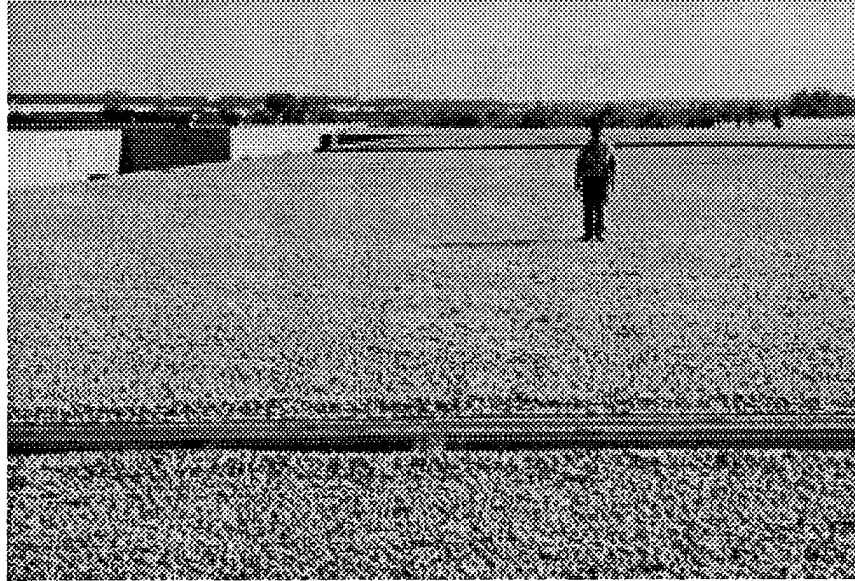
ure 14. Figure 15 shows it again along with the bright thermal image that extends from it onto this roof. A few orange spray painted marks were made on the roof to indicate where this bright 2-ft-wide, 52-ft-long (0.6- × 16-m) strip is located. It is parallel to and about 50 ft (15.2 m) from the east edge of this roof. We did not core the roof in this area, so we do not know for sure if it contains wet

insulation. Our uncertainty is due to differences in ballast color in this area, which are also, in part, responsible for the bright thermal images. The owner may wish to investigate this further to determine if wet EPS or wet fibrous glass is present since, as stated for roofs D1 and D2, moisture in each insulation should be responded to in a different way. If the EPS is wet, the EPDM membrane

*Figure 15. Roof D3, looking south from the expansion joint that separates it from roof D2. The bright area on the thermogram may indicate the presence of wet insulation.*

should be inspected closely with the goal of finding the flaw(s) where water bypassed the waterproofing system.

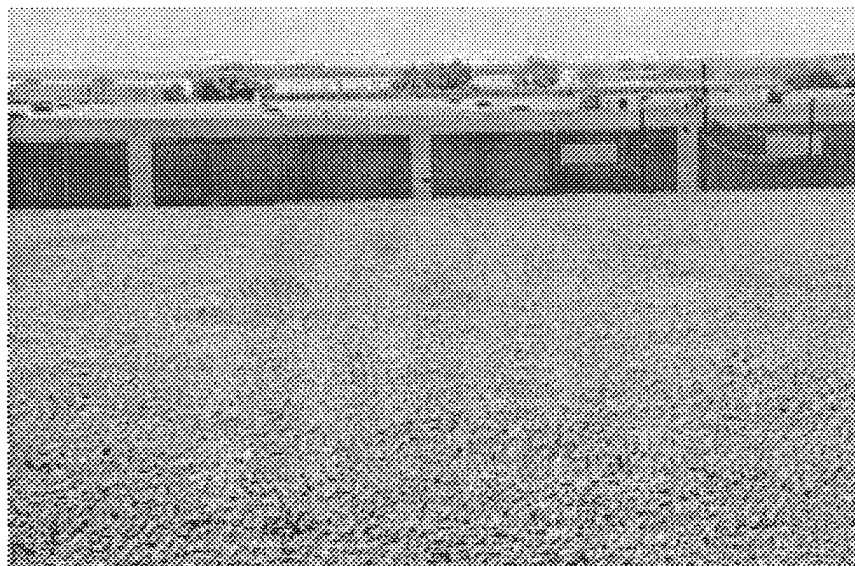
The western half of this roof contained numerous parallel bands of brightness when viewed with the infrared scanner. Figure 16 shows a photograph and thermogram of three such bands. They were all caused by differences in the ballast. All

bright areas correspond to bands of dark ballast as can be seen in the Figure 16 photograph. Core 10, the only sample taken on this roof, was taken in one of the bright areas to verify that all the brightness was caused by dark ballast. Its location is shown in Figure 2. Table 5 presents the information obtained at core 10. It verified that these bright bands were *not* moisture related.

Figure 16. Roof D3, looking west. The bright bands on the thermogram are due to dark ballast in those areas as shown in the photograph. Core 10, taken in one of the bright bands, verified that the brightness is not due to wet insulation.

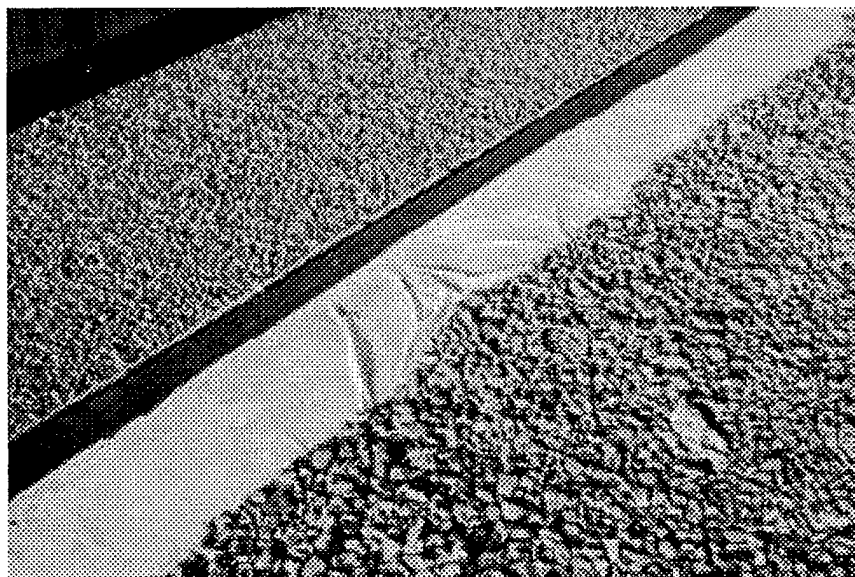
*Figure 18. Raised edge of roof D5 showing wrinkled Hypalon.*

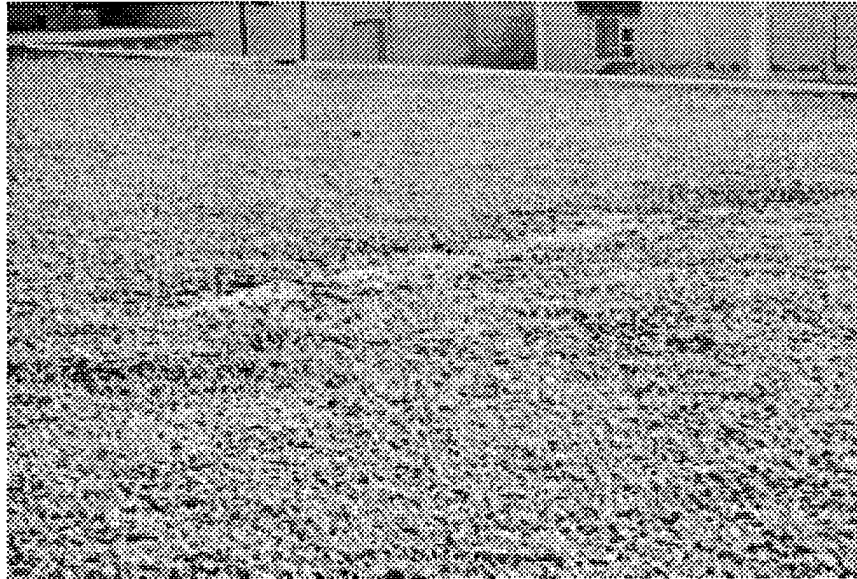
*Figure 19. Bare area on roof D5, looking southwest.*

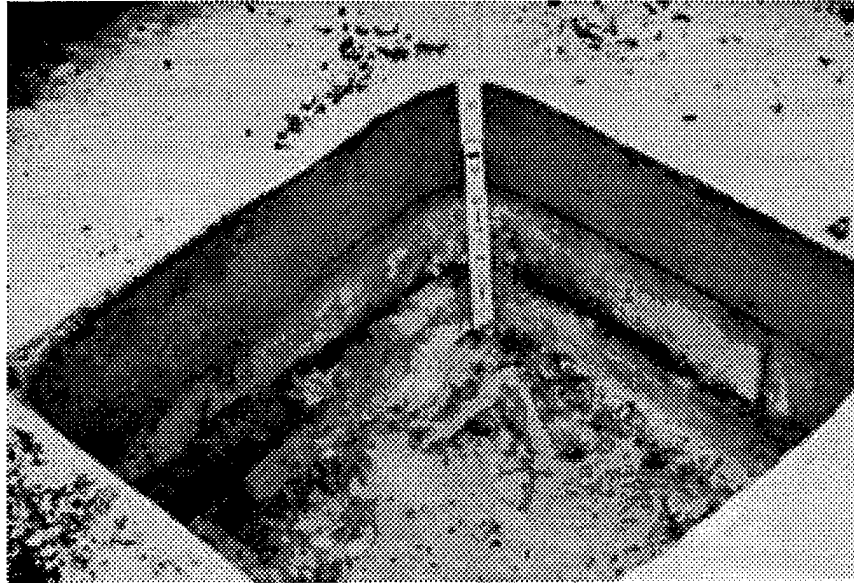
Figure 21. Cut D on roof D5 showing layers of perlite and fibrous glass insulation.

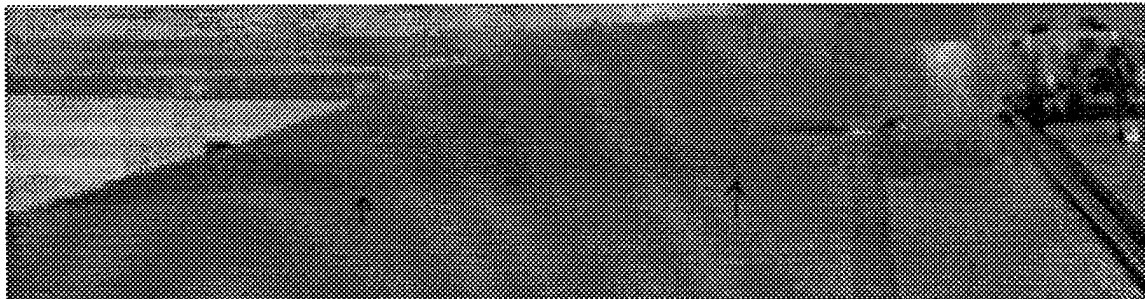
Figure 24. Thermogram showing the cold band caused by movement of cold water from refrigeration equipment across roof D7, looking north.

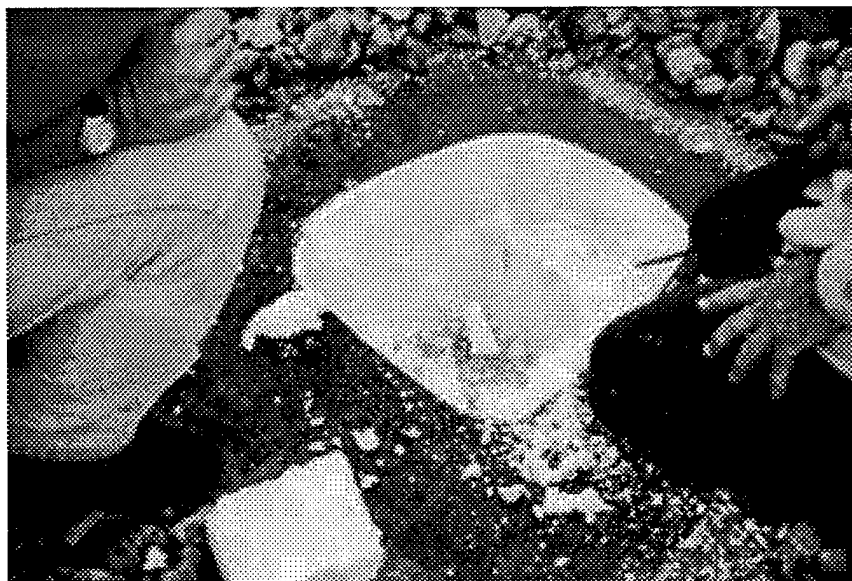
**Figure 25. Taking cut F on roof D7. The lower layer of EPS was "full" of ice and frozen to the deck. A 12- x12-in. sample of it could not be obtained.**

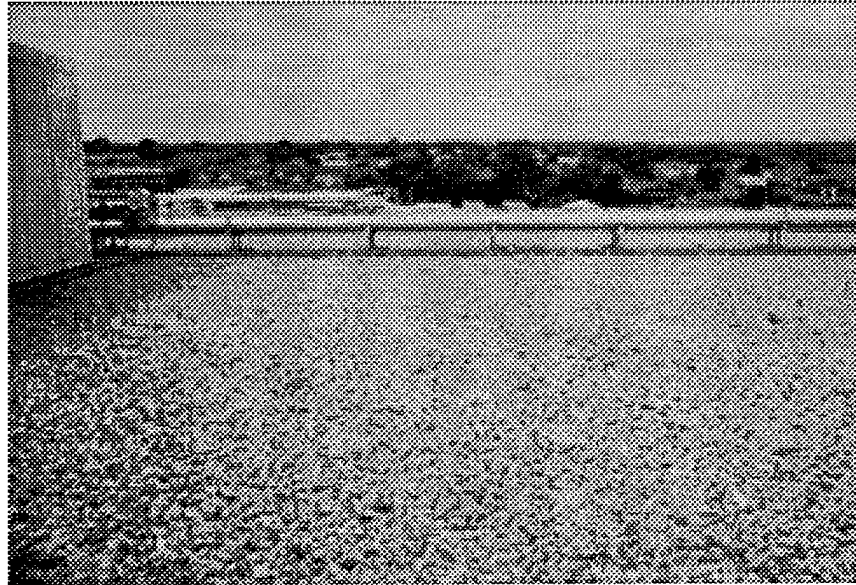
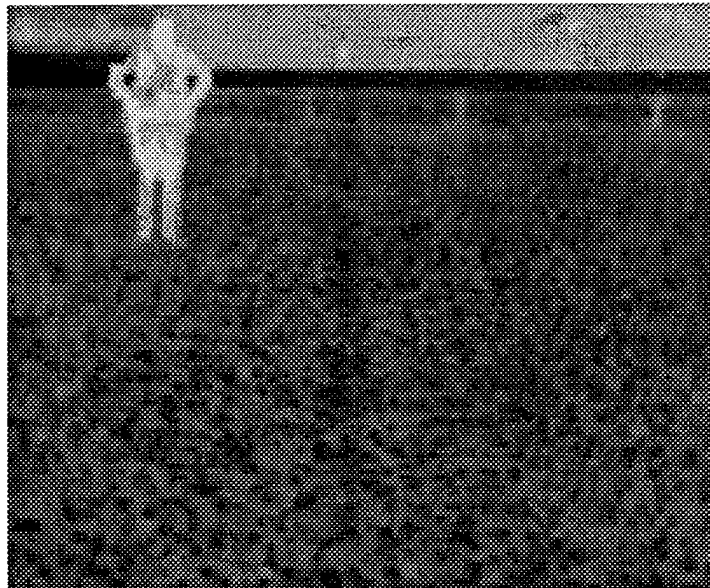
Figure 26. Photograph and thermogram of roof A1, looking west. The dark line in the thermogram is a hidden expansion joint.

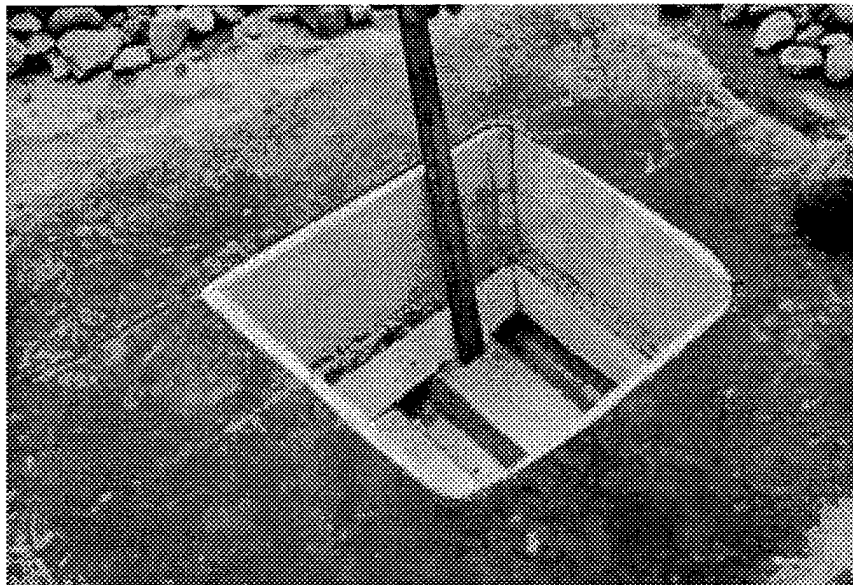
*Figure 27. Hole made in roof A1 when taking cut G. No rust existed on the steel deck.*

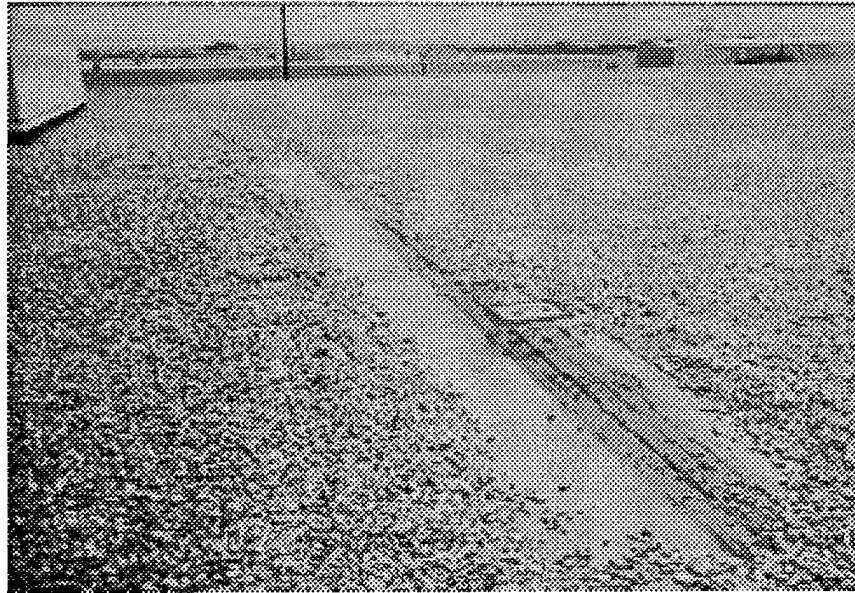
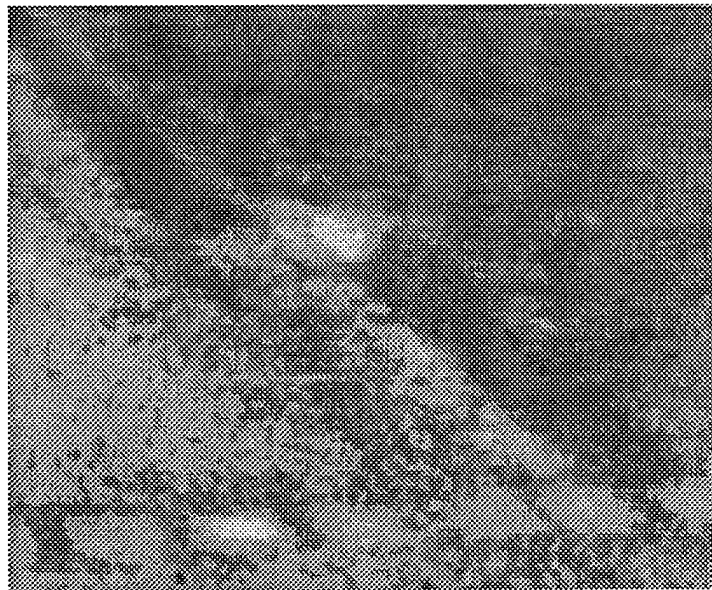
*Figure 28. Photograph and thermogram of the expansion joint that separates roofs A2 and A3, looking a little south of east. The bright spot on the thermogram suggests that wet insulation exists below the patch.*

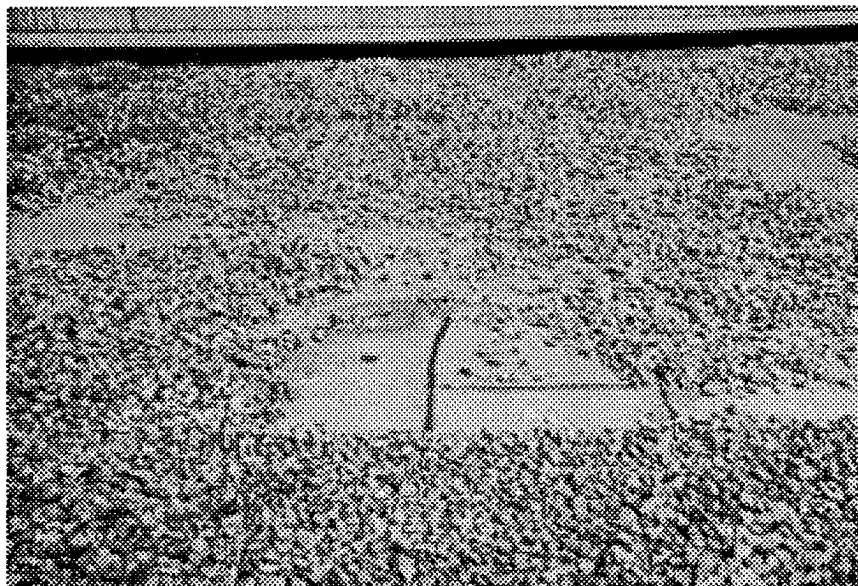
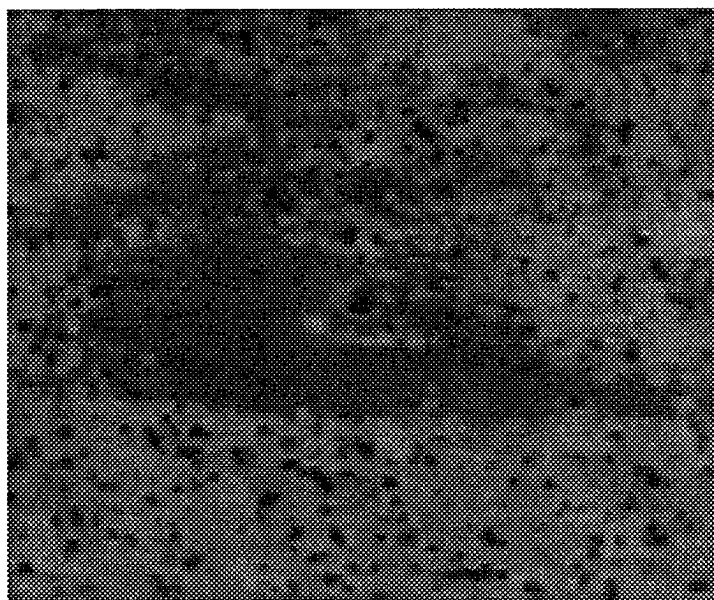
*Figure 29. Photograph and thermogram of disturbed ballast on roof A2, looking north. The spray painted lines outline some insulation boards and the dot is where core 18 would soon be taken. Insulation was wet there.*

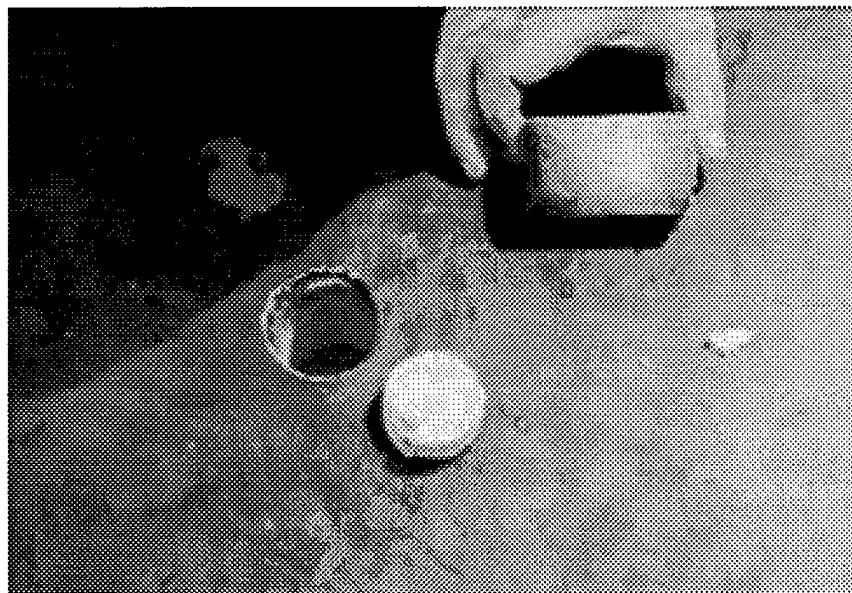
Figure 30. Upper layer of phenolic insulation at core 18.

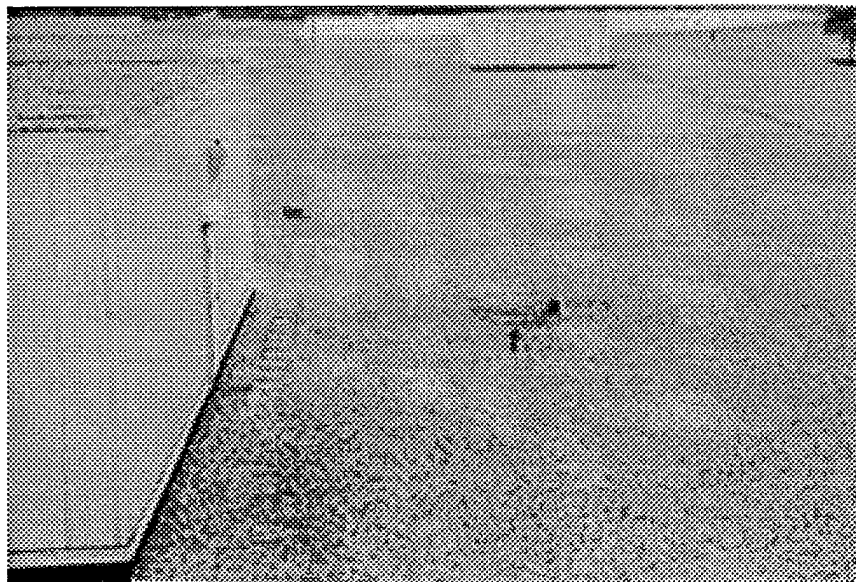
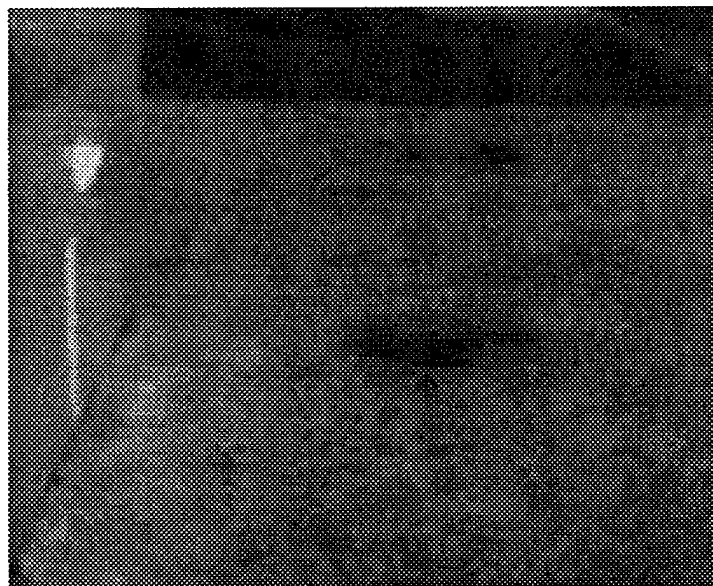
Figure 31 shows a thermally dark area to the west of the west penthouse on this roof. The photograph and the thermogram were taken from roof A1, which is about 9 ft (2.7 m) higher. Core 17 was taken in the middle of that dark area. As indicated in Table 16, core 17 contained wet phenolic insulation. We did not remove ballast in this area to search for the membrane flaw through which that

*Figure 31. Photograph and thermogram of a strong thermal anomaly on roof A2, looking south. Core 17, taken here, found wet insulation.*

moisture entered the roof. We expect that a search will find it within a 4-ft radius of the patch we made in the membrane where core 17 was taken.

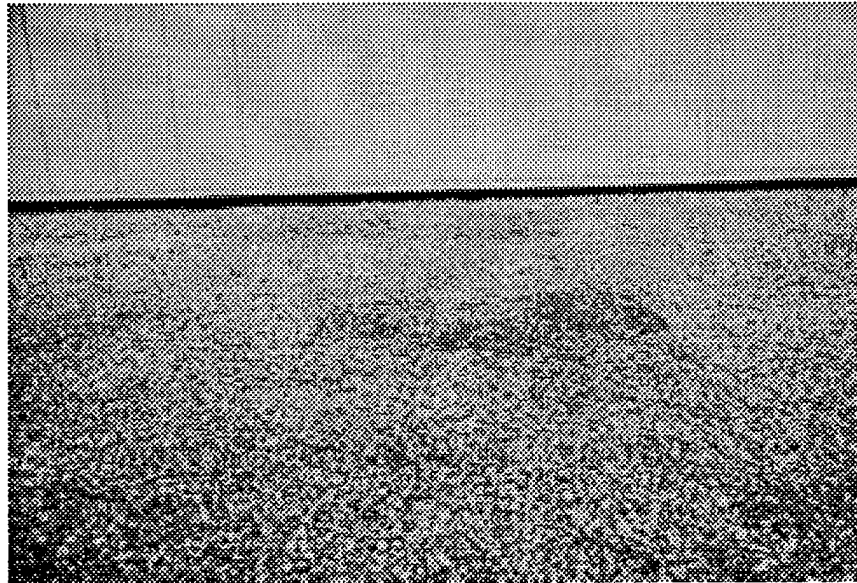
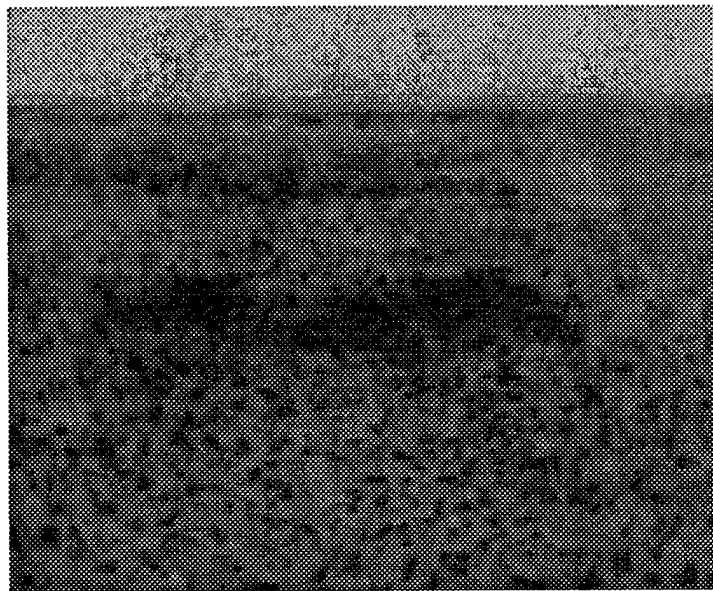
*Figure 32. Photograph and thermogram of another strong thermal anomaly on roof A2, looking north. Core 19, taken here, found wet insulation.*

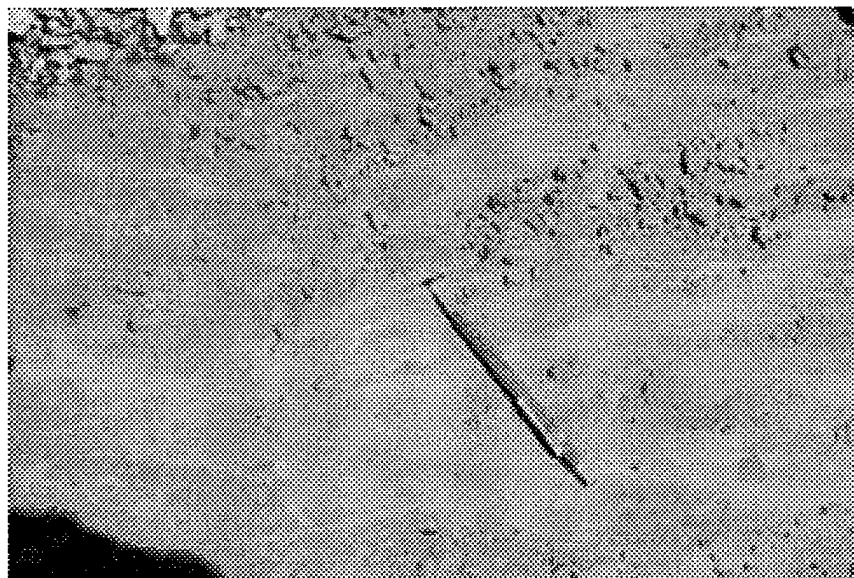
*Figure 33. Ballast contained a lot of fine soil where core 19 was taken. Note the membrane slit at the upper end of the pencil.*

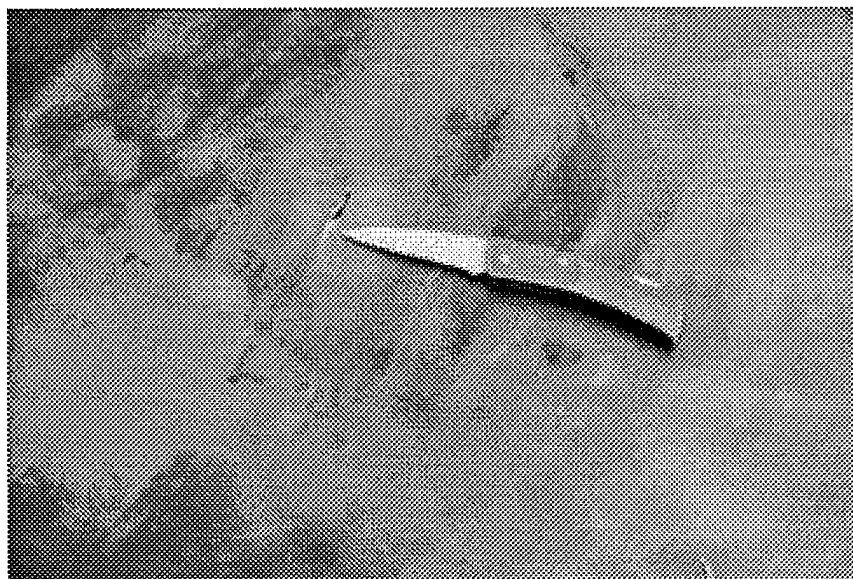
*Figure 34. The membrane slit shown in Figure 33 after cleaning the membrane.*

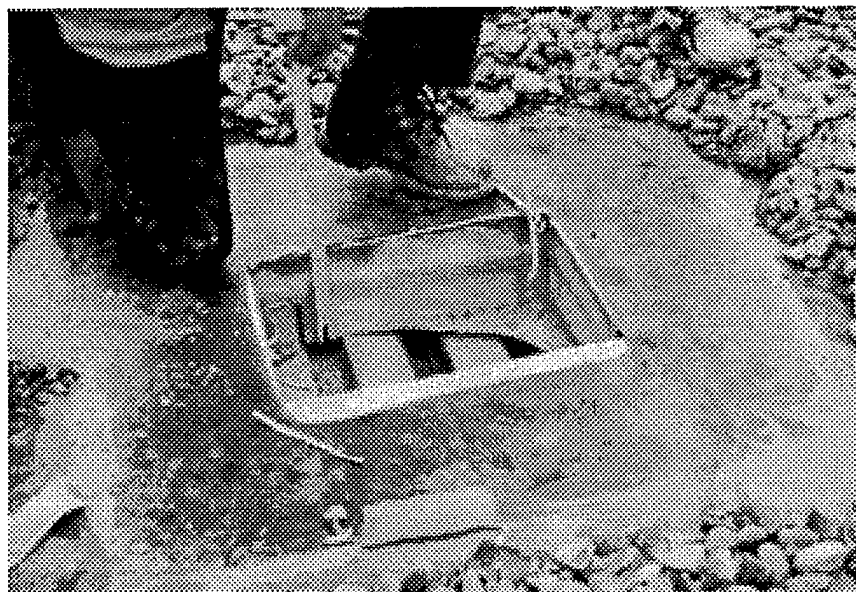
Figure 35. Cut H on roof A2. A small amount of rust was present in the flutes of the steel deck.

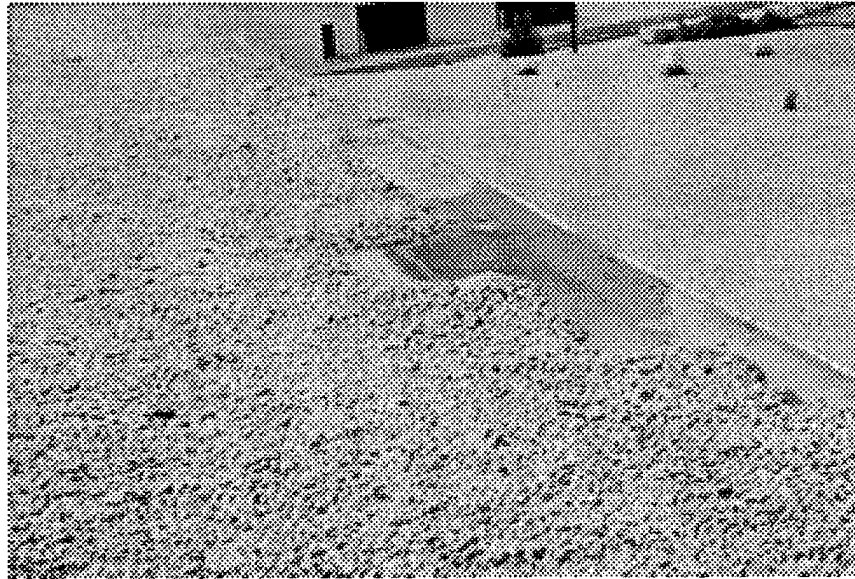
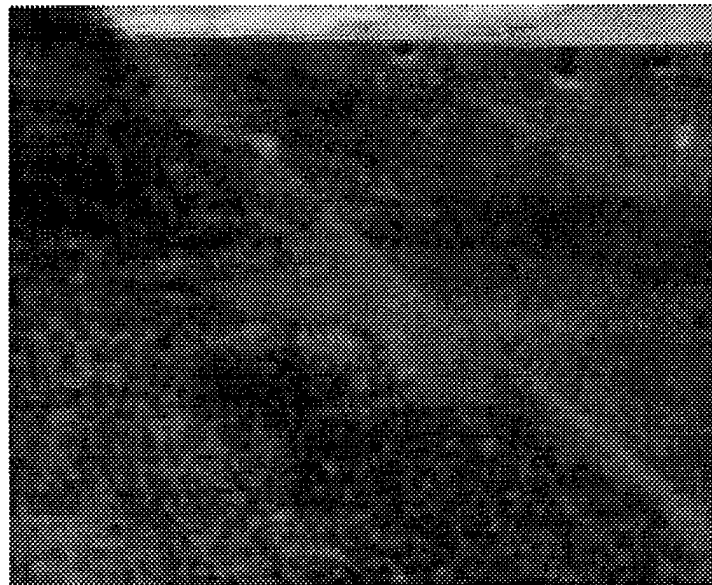
*Figure 36. Photograph and thermogram of bare membrane and ponded water along the west side of roof A3, looking SW.*

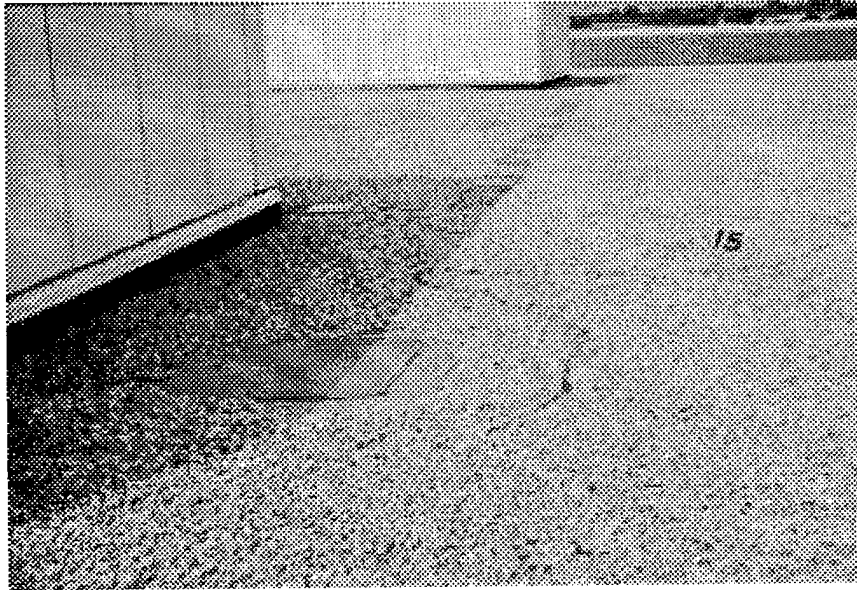
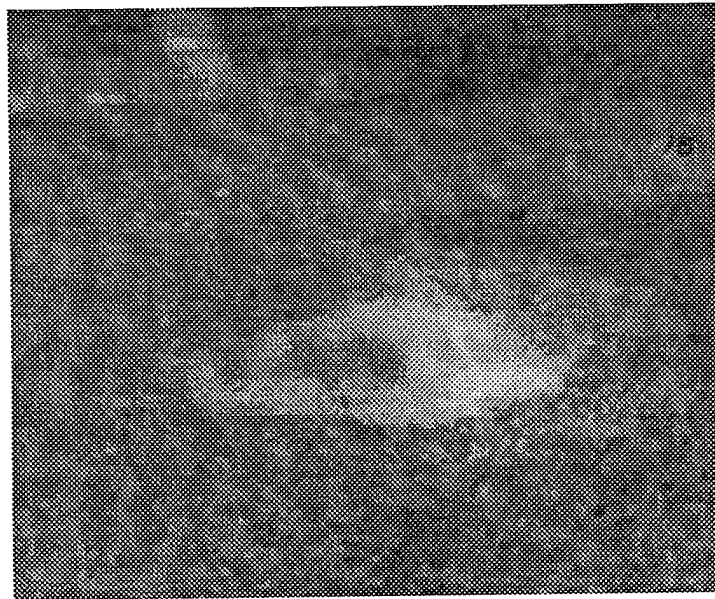
*Figure 37. Photograph and thermogram of an area of wet insulation that extends out beyond a patched bare area on the north side of the east penthouse on roof A3, looking a little south of west. Core 15 was taken at the "15."*

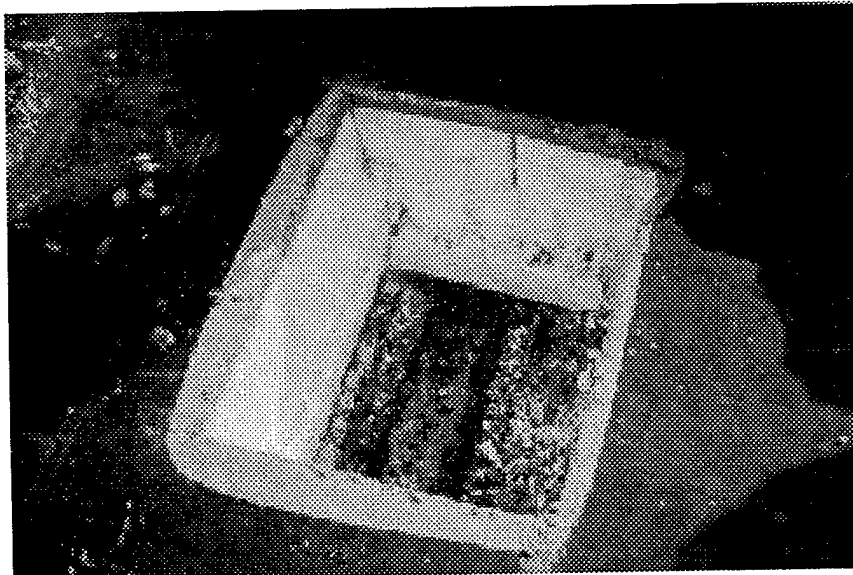
Figure 38. Hole made when taking core 14 and cut I. The bottom layer of perlite on the steel deck was wet and the steel was badly rusted.
